2013 BMW 550xi 4.4L Eng

# AIRBAG WARNING LAMP ILLUMINATED; SHORTED WIRE IN FRONT SEAT HARNESS

# TECHNICAL SERVICE BULLETIN

Reference Number(s): SI B65 01 13, Date of Issue: January, 2013 BMW: F07; F10; Produced from May 31, 2009 GROUP: Audio, Navigation, Monitors, Alarms, SRS

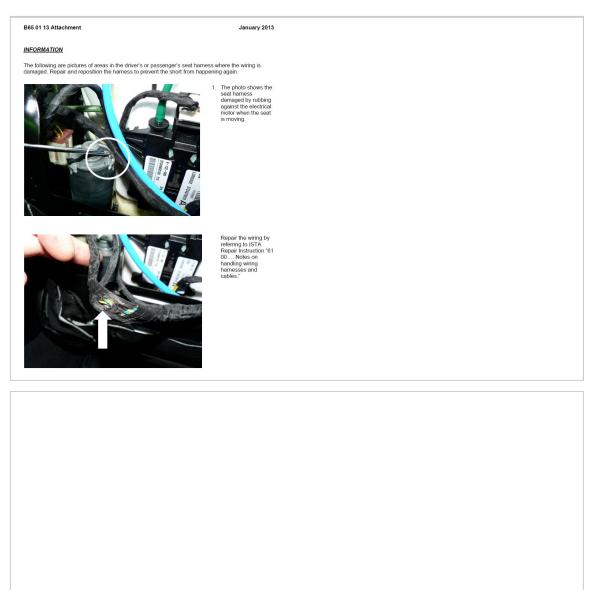
Inspect the seatback frame for sharp edges which may damage the harness.

You can use felt strip P/N 54 13 7 181 349 to protect the harness from rubbing against sharp edges.

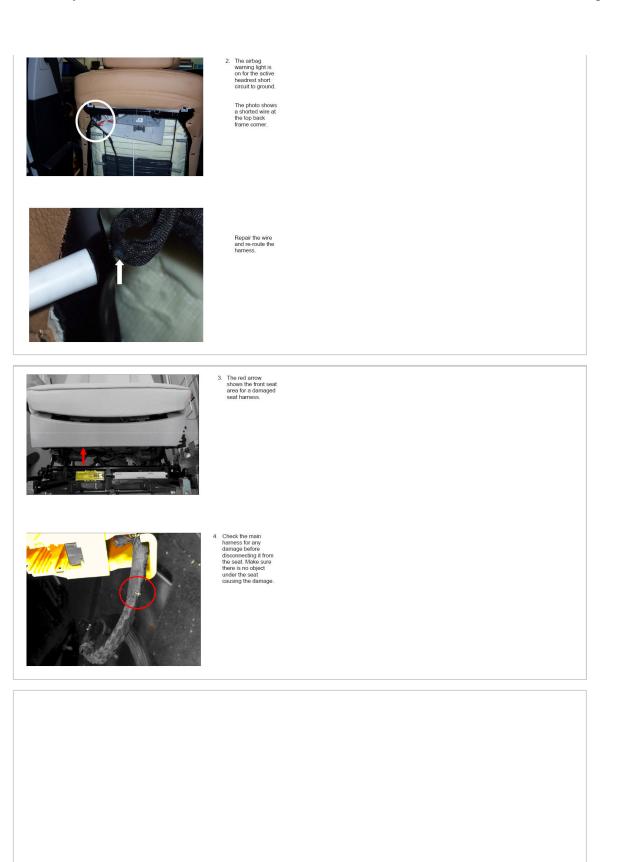
In the seat bottom frame look for the harness rubbing against the spring, electric motor, sharp edges, hinges, etc...

Use self-adhesive felt strip P/N 52 20 7 276 398 to protect the harness from rubbing at these locations.
